**Flood Control Project Maintenance  
Levee Inspections**

**Maintenance Issue Types Only, Levee Inspection Report By Mile - Fall 2018**

**Reclamation District No. 1001 Nicolaus**

Waterway	Bank	Unit Miles	Inspection Start/End	Inspector
Unit No. 01 Yankee Slough	Right	4.12	10/09/2018 10/09/2018	Sterling York

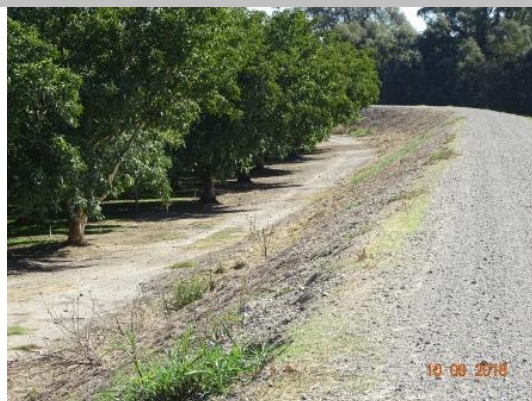
Photo 1 of 1 : FA\_2018\_RD1001\_36\_11\_20181113\_00020.jpg

LM Start	0.01	Rating **	A	Issue No.	11
LM End	4.11	Issue Type +	Ma	Location *	LS
Category	Earthen Levee			GPS Latitude/Longitude	
				Start	End
Item	Vegetation			38.980182°	38.970629°
				-121.470263°	-121.534464°
DWR ID	DWR_RD1001_01_f_2018_11				
Comment Code					
V1 : Control annual grass and weeds on the levee slopes and easements.					
Inspector Comment					
The annual vegetation is well maintained, Fall 2018.

View looking upstream landside at the well maintained annual vegetation, Fall 2018.

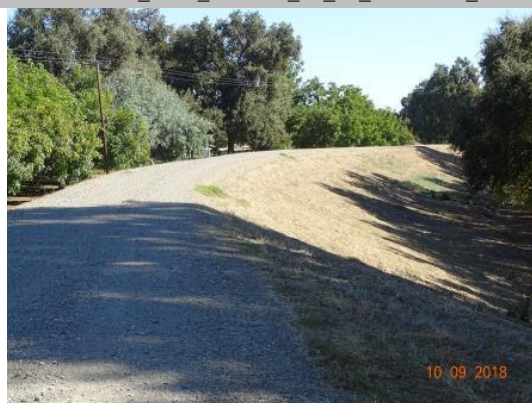
Photo 1 of 1 : FA\_2018\_RD1001\_36\_12\_20181113\_00019.jpg

LM Start	0.01	Rating **	A	Issue No.	12
LM End	4.11	Issue Type +	Ma	Location *	WS
Category	Earthen Levee			GPS Latitude/Longitude	
				Start	End
Item	Vegetation			38.980182 °	38.970629 °
				-121.470263 °	-121.534464 °
DWR ID	DWR_RD1001_01_f_2018_12				
Comment Code					
V1 : Control annual grass and weeds on the levee slopes and easements.					
Inspector Comment					
The annual vegetation is well maintained, Fall 2018.

View looking upstream waterside at the well maintained annual vegetation, Fall 2018.

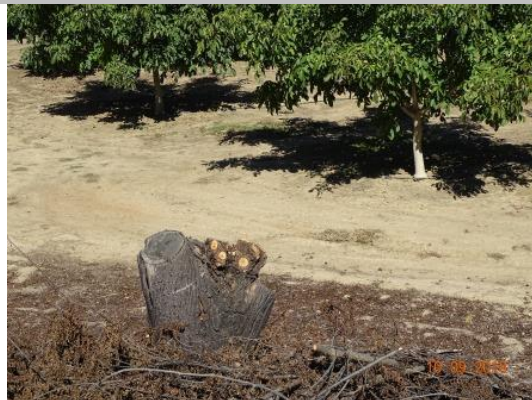
Photo 1 of 2 : FA\_2018\_RD1001\_36\_19\_20181113\_00021.jpg

LM Start	3.09	Rating **	A	Issue No.	19
LM End	3.09	Issue Type +	Ma	Location *	LS
Category	Earthen Levee			GPS Latitude/Longitude	
				Start	End
Item	Trim / Thin Trees			38.965660 °	38.965660 °
				-121.520548 °	-121.520548 °
DWR ID	DWR_RD1001_01_s_2016_19				
Comment Code					
T1 : Trim trees to at least five feet above ground level.					
Inspector Comment					
Limbs are removed from stump for access and visibility, Fall 2018.

View of a tree that limbs are trimmed and trunk sprayed to prevent any future growth, Fall 2018.

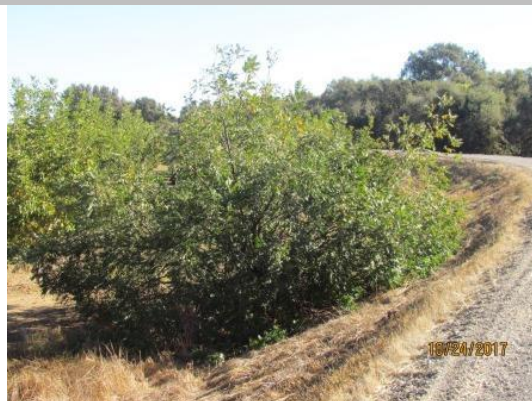
Photo 2 of 2 : FA\_2018\_RD1001\_36\_19\_20180918\_00013.jpg

View of a tree that need limbs trimmed. Fall 2017.

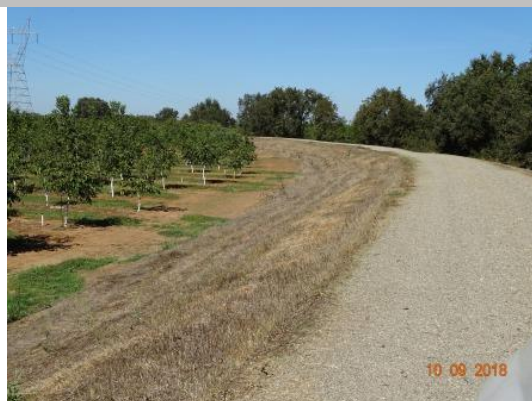
Photo 1 of 1 : FA\_2018\_RD1001\_35\_7\_20181113\_00028.jpg

View looking downstream landside at the well maintained annual vegetation, Fall 2018.

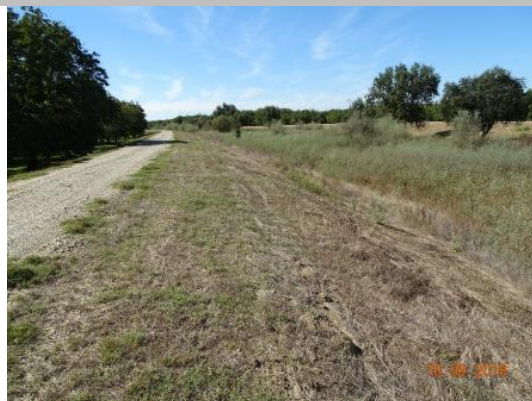
Photo 1 of 1 : FA\_2018\_RD1001\_35\_8\_20181113\_00029.jpg

LM Start	0.00	Rating **	A	Issue No.	8
LM End	3.64	Issue Type +	Ma	Location *	WS
Category	Earthen Levee			GPS Latitude/Longitude	
				Start	End
Item	Vegetation			38.971222°	38.965811°
				-121.474028°	-121.533591°
DWR ID	DWR_RD1001_02_f_2018_8				
Comment Code					
V1 : Control annual grass and weeds on the levee slopes and easements.					
Inspector Comment					
The annual vegetation is well maintained, Fall 2018.

View looking downstream waterside at the well maintained annual vegetation, Fall 2018.

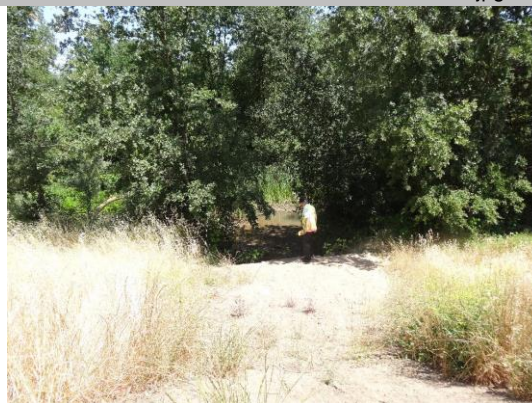
Photo 1 of 3 : UCIP\_FA\_2018\_14008\_23108.jpg

Comment Code						
Inspector Comment						
FS_ID:14008 DS_ID:22543 EP_NO: N/A Repair Type: Non-Urgent Crossing Status: Found UCIP Comments: 05/23/2013 - slide gate in inlet pipe on landside - pits on pipe due to corrosion (P. Amatya - DWR UCIP) FIELD_STRUCT_DESC: 36-inch corrugated metal gravity drainage pipe through the levee, 15 feet below the crown. Flap gate and concrete U-shaped headwall at outfall on the waterside (WS) end. Slide gate at inlet on the landside (LS) end. (Reclamation District No. 1001). [Additional Reference(s): DWR Levee Log, 1993. USACE Sacramento O&M Manual 141.1, August 1955, (Station 67+75)]. FS Date: 5/23/2013

WS- overview of waterside of the levee.

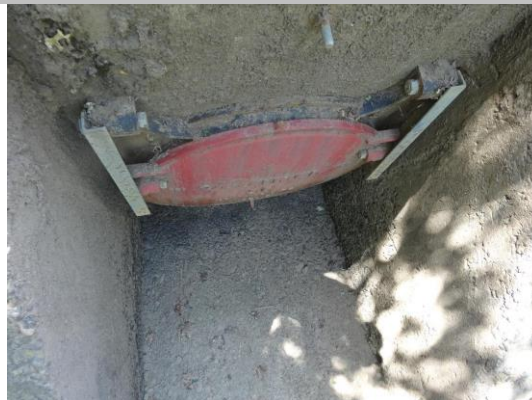
Photo 2 of 3 : UCIP\_FA\_2018\_14008\_23107.jpg

WS- outfall pipe with flap gate in concrete wing wall.

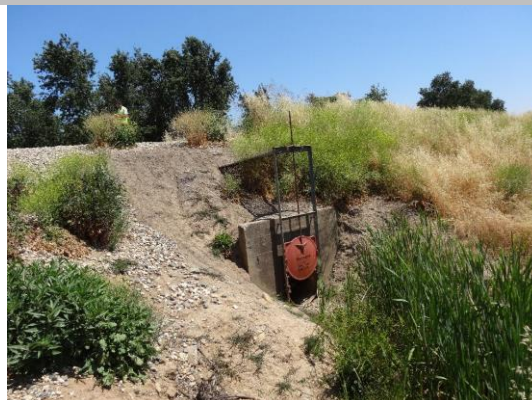
Photo 3 of 3 : UCIP\_FA\_2018\_14008\_23106.jpg

Comment Code						
Inspector Comment						
FS_ID:14008 DS_ID:22543 EP_NO: N/A Repair Type: Non-Urgent Crossing Status: Found UCIP Comments: 05/23/2013 - slide gate in inlet pipe on landside - pits on pipe due to corrosion (P. Amatya - DWR UCIP) FIELD_STRUCT_DESC: 36-inch corrugated metal gravity drainage pipe through the levee, 15 feet below the crown. Flap gate and concrete U-shaped headwall at outfall on the waterside (WS) end. Slide gate at inlet on the landside (LS) end. (Reclamation District No. 1001). [Additional Reference(s): DWR Levee Log, 1993. USACE Sacramento O&M Manual 141.1, August 1955, (Station 67+75)]. FS Date: 5/23/2013

LS- slide gate in inlet pipe structure

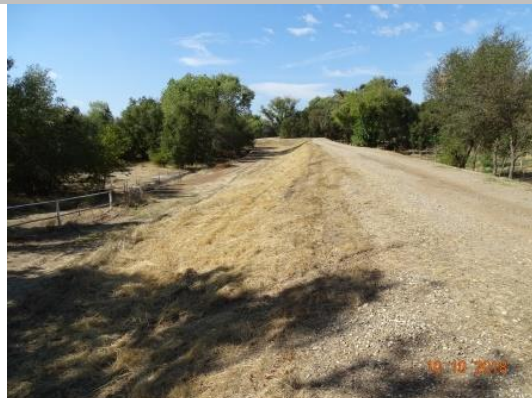
Photo 1 of 1 : FA\_2018\_RD1001\_37\_14\_20181113\_00041.jpg

View looking downstream landside at the well maintained annual vegetation, Fall 2018.

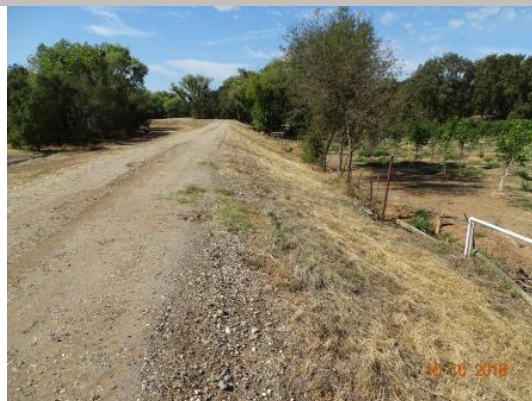
Photo 1 of 1 : FA\_2018\_RD1001\_37\_15\_20181113\_00042.jpg

LM Start	0.01	Rating **	A	Issue No.	15
LM End	12.57	Issue Type +	Ma	Location *	WS
Category	Earthen Levee			GPS Latitude/Longitude	
				Start	End
Item	Vegetation			39.006570 °	38.941182 °
				-121.375116 °	-121.567543 °
DWR ID	DWR_RD1001_03_f_2018_15				
Comment Code					
V1 : Control annual grass and weeds on the levee slopes and easements.					
Inspector Comment					
The annual vegetation is well maintained, Fall 2018.

View looking downstream waterside at the well maintained annual vegetation, Fall 2018.

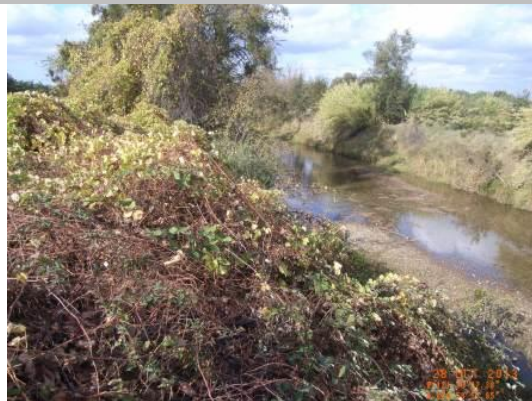
Photo 1 of 1 : FA\_2018\_RD1001\_37\_13\_20181114\_00013.jpg

LM Start	7.22	Rating **	M	Issue No.	13
LM End	7.31	Issue Type +	Ma	Location *	WS
Category	Supplemental			GPS Latitude/Longitude	
				Start	End
Item	2017 USACE Erosion Survey, DRAFT			38.982737 °	38.982572 °
				-121.501144 °	-121.502797 °
DWR ID	DWR_RD1001_03_f_2018_13				
Comment Code					
Inspector Comment					
2017 Site ID: BER 5.7 L					
Status: Eroding					
2017 Field Notes: Minor new erosion observed.					
Site History: 2008 - Sandy/silty banks with rotational slab failures					
creating near vertical bank with pop-outs due to tree failures. Narrow					
berm.

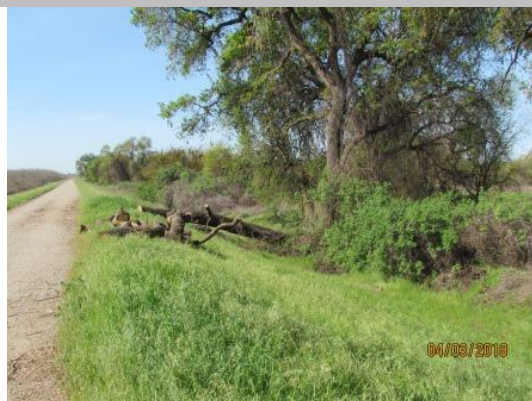
Photo 1 of 1 : FA\_2018\_RD1001\_37\_25\_20180918\_00014.jpg

View looking downstream waterside of a fallen tree that needs to be removed.

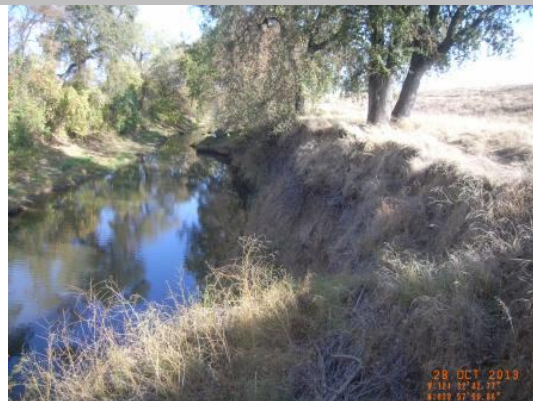
Photo 1 of 1 : FA\_2018\_RD1001\_37\_12\_20181114\_00010.jpg

LM Start	10.36	Rating **	M	Issue No.	12
LM End	10.40	Issue Type +	Ma	Location *	WS
Category	Supplemental			GPS Latitude/Longitude	
				Start	End
Item	2017 USACE Erosion Survey, DRAFT			38.964583 °	38.964010 °
				-121.544967 °	-121.545228 °
DWR ID	DWR_RD1001_03_f_2018_12				
Comment Code					
Inspector Comment					
2017 Site ID: BER 2.5 L					
Status: Eroding					
2017 Field Notes: Erosion pockets have expanded					
Site History: 2011 - Large section of bank has slumped off. RD has flagged and appears to be watching. 2012 - Slopes slightly steeper.					
2013 - Minor new erosion observed.

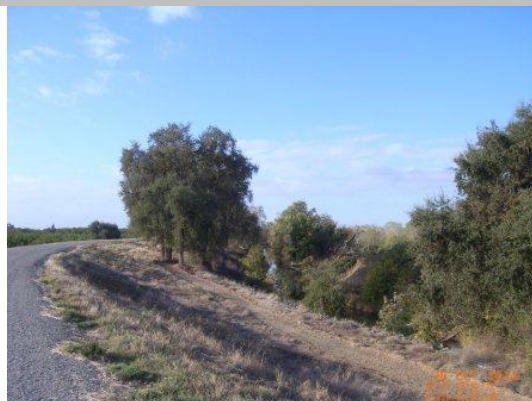
Photo 1 of 1 : FA\_2018\_RD1001\_37\_10\_20181114\_00007.jpg

LM Start	11.08	Rating **	A/W	Issue No.	10
LM End	11.16	Issue Type +	Ma	Location *	WS
Category	Supplemental			GPS Latitude/Longitude	
				Start	End
Item	2017 USACE Erosion Survey, DRAFT			38.955070 °	38.954227 °
				-121.549528 °	-121.550592 °
DWR ID	DWR_RD1001_03_f_2018_10				
Comment Code					
Inspector Comment					
2017 Site ID: BER 1.9 L					
Status: Eroding					
2017 Field Notes: Minor new erosion observed.					
Site History: 2011 - Large slumped sections of bank. 2012 - Slopes slightly steeper.

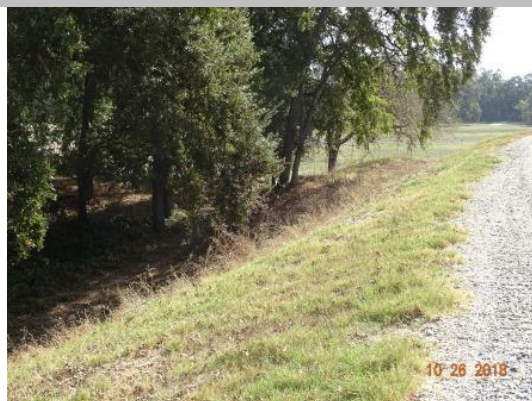
Photo 1 of 2 : FA\_2018\_RD1001\_38\_64\_20181114\_00077.jpg

LM Start	0.37	Rating **	A/W	Issue No.	64
LM End	0.37	Issue Type +	Ma	Location *	LS
Category	Earthen Levee			GPS Latitude/Longitude	
				Start	End
Item	Slope Stability			38.935903 °	38.935903 °
				-121.567250 °	-121.567250 °
DWR ID	DWR_RD1001_04_s_2016_64				
Comment Code					
S1 : Repair slope instability.					
Inspector Comment					
Animal trail is not being used and shows no sign of erosion or sloughing. Fall 2017.

View looking downstream of animal trail that is not being used and shows no sign of erosion or sloughing. Fall 2018.

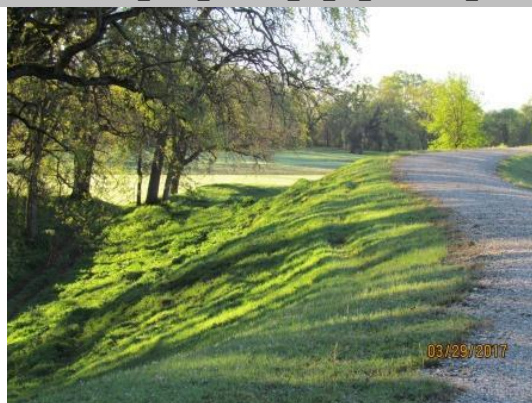
Photo 2 of 2 : FA\_2018\_RD1001\_38\_64\_20180918\_00040.jpg

View looking downstream of animal trail that is not being used and shows no sign of erosion or sloughing. Spring 2017.

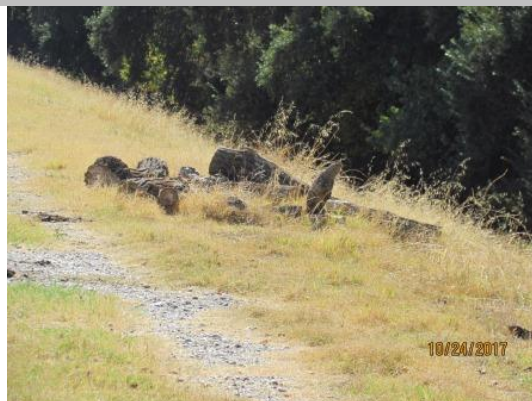
Photo 1 of 1 : FA\_2018\_RD1001\_38\_65\_20180918\_00041.jpg

View looking downstream waterside crown at firewood.

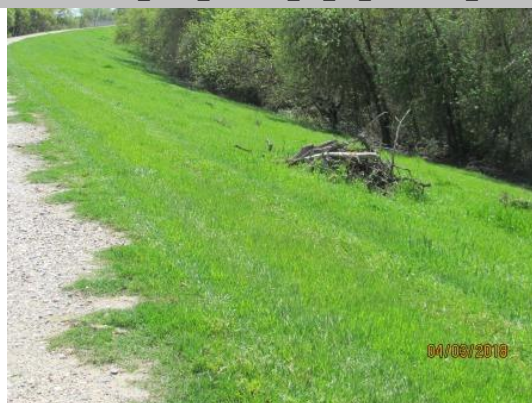
Photo 1 of 1 : FA\_2018\_RD1001\_38\_67\_20180918\_00045.jpg

LM Start	1.51	Rating **	M	Issue No.	67
LM End	1.51	Issue Type +	Ma	Location *	WS
Category	Earthen Levee			GPS Latitude/Longitude	
				Start	End
Item	Encroachments			38.919643 °	38.919643 °
				-121.569233 °	-121.569233 °
DWR ID	DWR_RD1001_04_f_2017_67				
Comment Code					
PR : Prunings					
Inspector Comment					
Remove pruning's from levee slope.

View looking downstream waterside of pruning's on the levee slope.

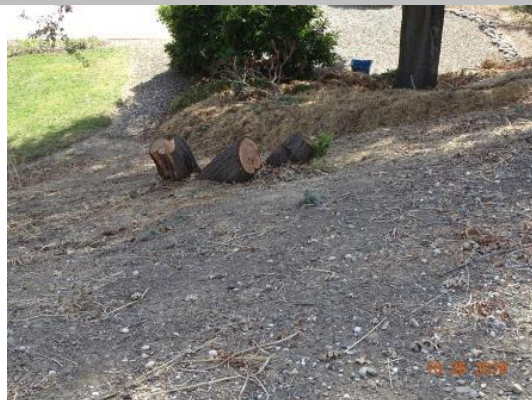
Photo 1 of 1 : FA\_2018\_RD1001\_38\_71\_20181114\_00084.jpg

LM Start	2.44	Rating **	N	Issue No.	71
LM End	2.44	Issue Type +	Ma	Location *	LS
Category	Earthen Levee			GPS Latitude/Longitude	
				Start	End
Item	Trim / Thin Trees			38.907466 °	38.907466 °
				-121.575413 °	-121.575413 °
DWR ID	DWR_RD1001_04_f_2018_71				
Comment Code					
T5 : Tree stumps.					
Inspector Comment					
Stumps should be removed from levee slope, Fall 2018.

View looking landside at stumps from a fallen and removed tree, Fall 2018.

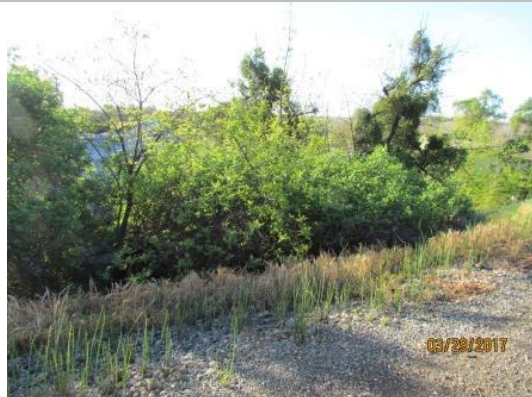
Photo 1 of 1 : FA\_2018\_RD1001\_38\_47\_20180918\_00027.jpg

View looking downstream where limbs need to be trimmed 5' for visibility.

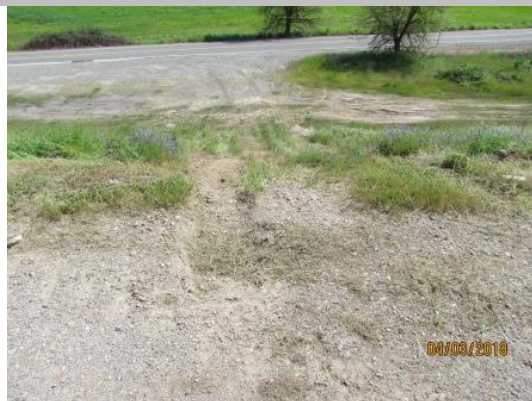
Photo 1 of 1 : FA\_2018\_RD1001\_38\_51\_20180918\_00031.jpg

LM Start	4.06	Rating **	M	Issue No.	51
LM End	4.09	Issue Type +	Ma	Location *	LS
Category	Earthen Levee			GPS Latitude/Longitude	
				Start	End
Item	Slope Stability			38.892820 °	38.892583 °
				-121.598003 °	-121.598575 °
DWR ID	DWR_RD1001_04_s_2017_51				
Comment Code					
S3 : Repair the levee slope damaged by vehicle traffic and prevent access where possible.					
Inspector Comment					
Continual vehicles driving up levee slope should be monitored and maintained, Spring 2018.

View of continual vehicles driving up levee slope, should be monitored and maintained.

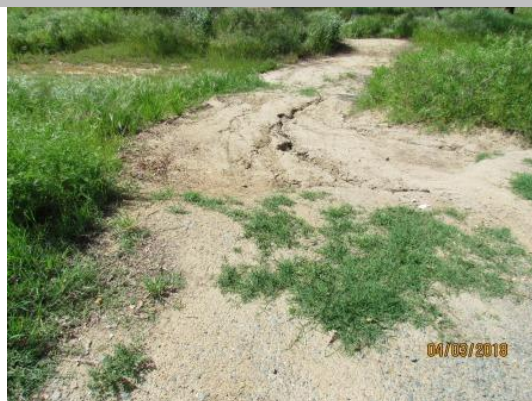
Photo 1 of 1 : FA\_2018\_RD1001\_38\_70\_20180918\_00049.jpg

LM Start	5.18	Rating **	M	Issue No.	70
LM End	5.18	Issue Type +	Ma	Location *	WS
Category	Earthen Levee			GPS Latitude/Longitude	
				Start	End
Item	Slope Stability			38.882301°	38.882301°
				-121.611296°	-121.611296°
DWR ID	DWR_RD1001_04_f_2017_70				
Comment Code					
S3 : Repair the levee slope damaged by vehicle traffic and prevent access where possible.					
Inspector Comment					
Continual vehicles driving up levee slope should be monitored and maintained,Fall 2018.

View looking downstream waterside of the slope that is damage by vehicle traffic.

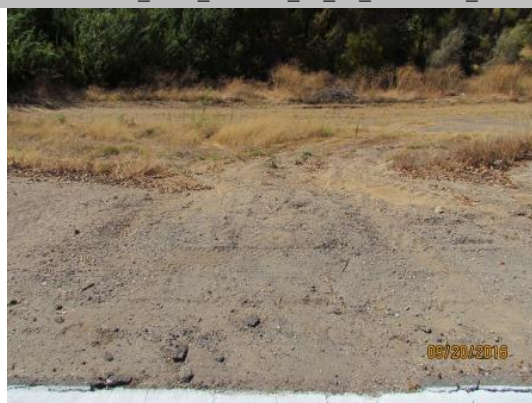
Photo 1 of 1 : FA\_2018\_RD1001\_38\_78\_20180918\_00051.jpg

LM Start	5.22	Rating **	M	Issue No.	78
LM End	5.22	Issue Type +	Ma	Location *	WS
Category	Earthen Levee			GPS Latitude/Longitude	
				Start	End
Item	Slope Stability			38.881768 °	38.881768 °
				-121.611302 °	-121.611302 °
DWR ID	DWR_RD1001_04_s_2016_78				
Comment Code					
S3 : Repair the levee slope damaged by vehicle traffic and prevent access where possible.					
Inspector Comment					
Repair damage on slope cause by vehicle traffic, Fall 2018.

Ruts still there on waterside slope due to vehicles.

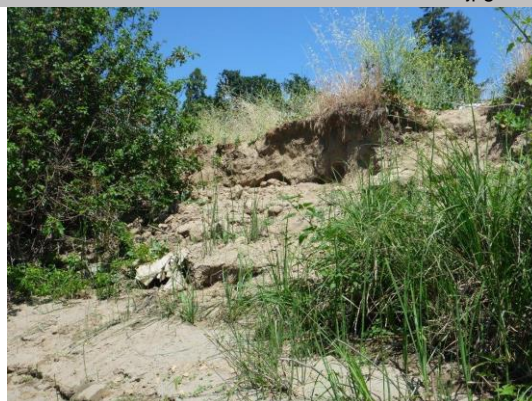
Photo 3 of 3 : LEVAL\_FA\_2018\_139\_1155.jpg

LM Start	5.61	Rating **	A/W	Issue No.	35 (cont)	
LM End		Issue Type +	Ma	Location *	WS	
Category	Supplemental			GPS Latitude/Longitude		
				Start	End	
Item	2017 Storm Damage			38.876374 °		°
				-121.613425 °		°
DWR ID	DWR_RD1001_04_f _ 2017_35					
Comment Code						
Inspector Comment						
Levee Evaluation Comments						
Description:						
Site ID No:139						
Site Designation:LMA-19						
Repair Type: Erosion						
Rating:Area of Concern						
Field Date:6/6/2017						
Notes: Several small erosion sites along 2 miles.

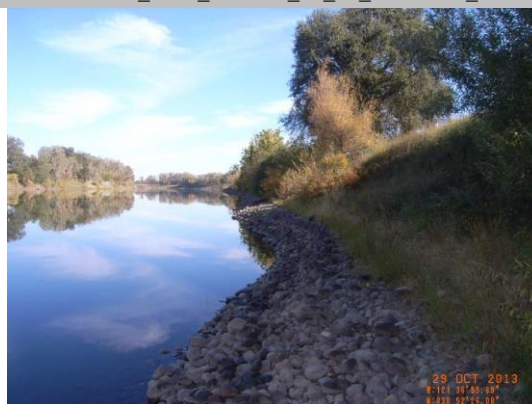
Photo 1 of 1 : FA\_2018\_RD1001\_38\_28\_20181114\_00037.jpg

LM Start	5.80	Rating **	A/W	Issue No.	28
LM End	5.93	Issue Type +	Ma	Location *	WS
Category	Supplemental			GPS Latitude/Longitude	
				Start	End
Item	2017 USACE Erosion Survey, DRAFT			38.874113 °	38.872373 °
				-121.615380 °	-121.616504 °
DWR ID	DWR_RD1001_04_f_2018_28				
Comment Code					
Inspector Comment					
2017 Site ID: FHR 6.6 L					
Status: Eroding					
2017 Field Notes: Sandy bank slope is unraveling.					
Site History: 2011 - Erosion pockets from tree popouts. Sections of the lower bank have slumped off. 2013 - Scallop from tree popouts no longer visible on site. Minor new erosion at the middle of the bank.					
2015 - Fresh erosion from human usage.

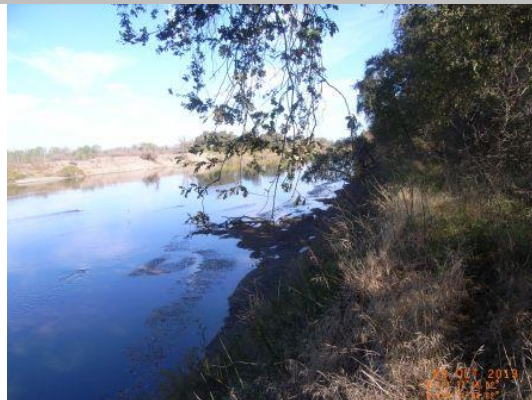
Photo 1 of 1 : FA\_2018\_RD1001\_38\_18\_20181114\_00032.jpg

LM Start	6.42	Rating **	U	Issue No.	18
LM End	6.51	Issue Type +	Ma	Location *	WS
Category	Supplemental			GPS Latitude/Longitude	
				Start	End
Item	2017 USACE Erosion Survey, DRAFT			38.865875 °	38.864706 °
				-121.619983 °	-121.620813 °
DWR ID	DWR_RD1001_04_f_2018_18				
Comment Code					
Inspector Comment					
2017 Site ID: FHR 6.0 L					
Status: Critical					
2017 Field Notes: Upgraded to critical, entire bank slope is slumping, with near vertical face					
Site History: 2011 - Tall slumping sections. Scour around trees has exposed most of the roots. 2016 - Recent large slope failure observed.

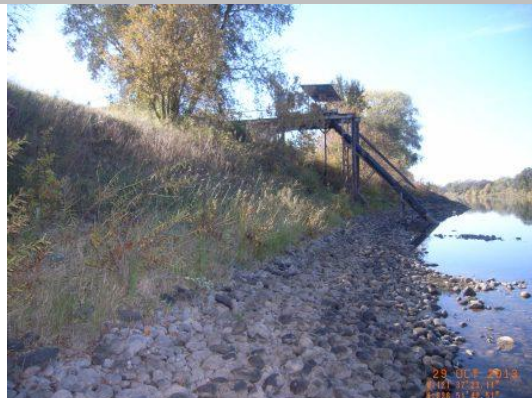
Photo 1 of 1 : FA\_2018\_RD1001\_38\_15\_20181114\_00030.jpg

LM Start	6.57	Rating **	A/W	Issue No.	15
LM End	6.77	Issue Type +	Ma	Location *	WS
Category	Supplemental			GPS Latitude/Longitude	
				Start	End
Item	2017 USACE Erosion Survey, DRAFT			38.863946 °	38.861558 °
				-121.621388 °	-121.623316 °
DWR ID	DWR_RD1001_04_f_2018_15				
Comment Code					
Inspector Comment					
2017 Site ID: FHR 5.8 L					
Status: Eroding					
2017 Field Notes: slope is not stable enough to maintain vegetation growth, new erosion					
Site History: 2011 - Large slumped sections on the lower bank. 2012 - New cracks observed.

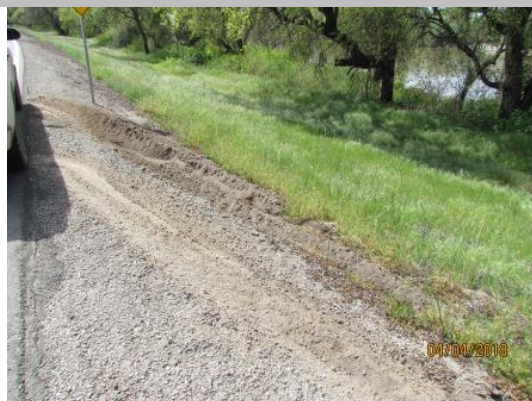
Photo 1 of 1 : FA\_2018\_RD1001\_38\_40\_20180918\_00021.jpg

LM Start	7.06	Rating **	M	Issue No.	40
LM End	7.06	Issue Type +	Ma	Location *	WS
Category	Earthen Levee			GPS Latitude/Longitude	
				Start	End
Item	Slope Stability			38.857797 °	38.857797 °
				-121.625912 °	-121.625912 °
DWR ID	DWR_RD1001_04_s_2018_40				
Comment Code					
S3 : Repair the levee slope damaged by vehicle traffic and prevent access where possible.					
Inspector Comment					
Repair tire ruts on levee slope.

View looking downstream waterside at deep tire ruts in levee slope.

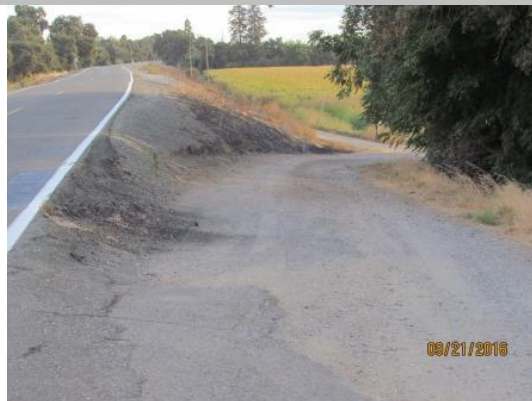
Photo 1 of 1 : FA\_2018\_RD1001\_38\_36\_20180918\_00019.jpg

LM Start	7.60	Rating **	A/W	Issue No.	36
LM End	7.60	Issue Type +	Ma	Location *	WS
Category	Earthen Levee			GPS Latitude/Longitude	
				Start	End
Item	Erosion / Bank Caving			38.850521 °	38.850521 °
				-121.629423 °	-121.629423 °
DWR ID	DWR_RD1001_04_f_2015_36				
Comment Code					
E2 : Schedule repair of erosion site prior to the next inspection.					
Inspector Comment					
Ramp has vertical cut into the levee prism.

View of vertical cut for ramp in the landside levee slope looking upstream.

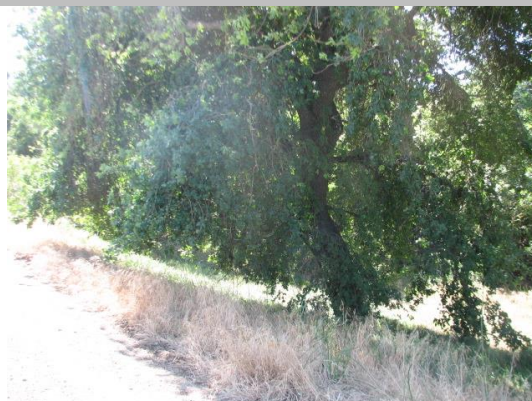
Photo 1 of 1 : FA\_2018\_RD1001\_38\_151\_20180918\_00054.jpg

Trees need to be trimmed up at least 5 feet.

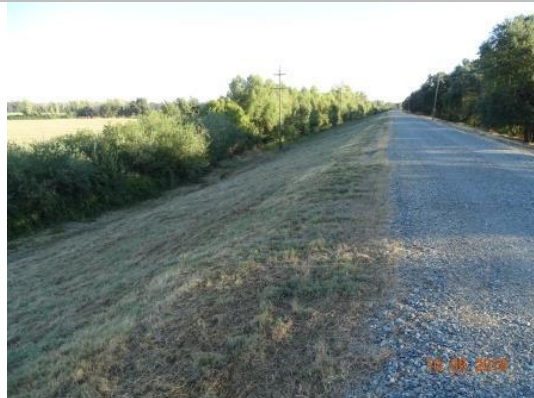
Photo 1 of 1 : FA\_2018\_RD1001\_39\_12\_20181114\_00019.jpg

View looking upstream landside at the well maintained annual vegetation, Fall 2018.

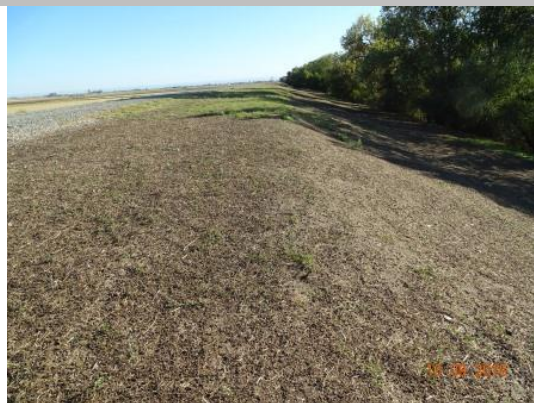
Photo 1 of 1 : FA\_2018\_RD1001\_39\_14\_20181114\_00021.jpg

View looking upstream waterside at the well maintained annual vegetation, Fall 2018.

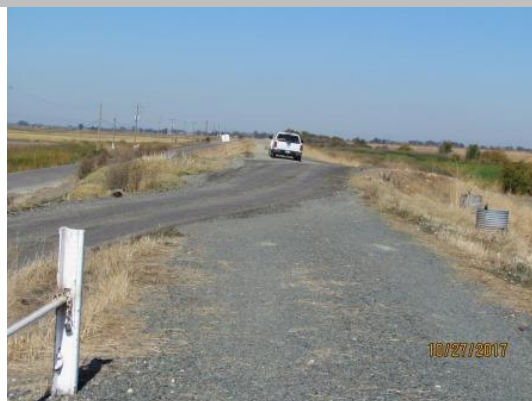
Photo 1 of 1 : FA\_2018\_RD1001\_40\_8\_20180918\_00003.jpg

View of crown where there is cross traffic looking upstream. Monitor this area and fix as needed.

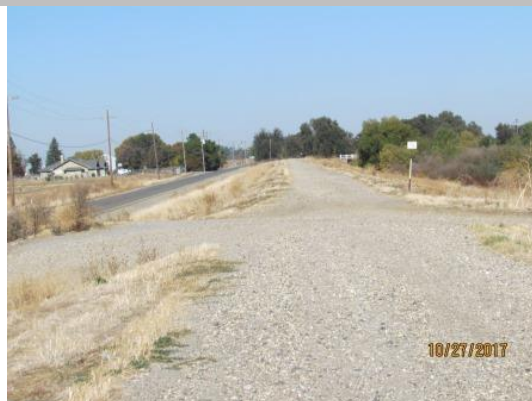
Photo 1 of 1 : FA\_2018\_RD1001\_40\_7\_20180918\_00002.jpg

View of crown where there is cross traffic looking upstream. Monitor this area and fix as needed.

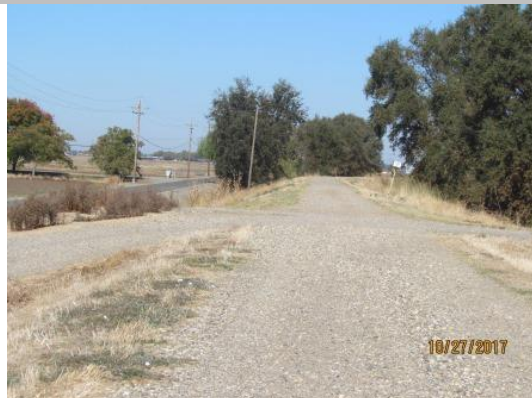
Photo 1 of 1 : FA\_2018\_RD1001\_40\_19\_20180918\_00005.jpg

View of crown where there is cross traffic looking upstream. Monitor this area and fix as needed.

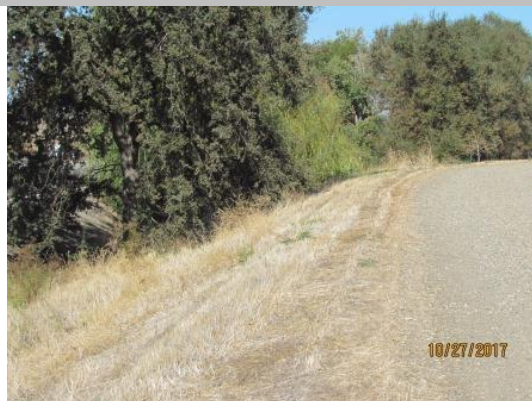
Photo 1 of 1 : FA\_2018\_RD1001\_40\_17\_20180918\_00004.jpg

View looking upstream landside at trees that need to be trimmed for access and visibility.

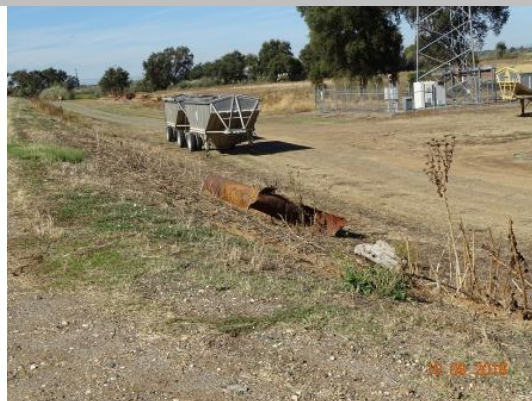
Photo 1 of 2 : FA\_2018\_RD1001\_40\_24\_20181114\_00041.jpg

View of an old piece of pipe still lying on landside levee slope looking downstream. Fall 2018.

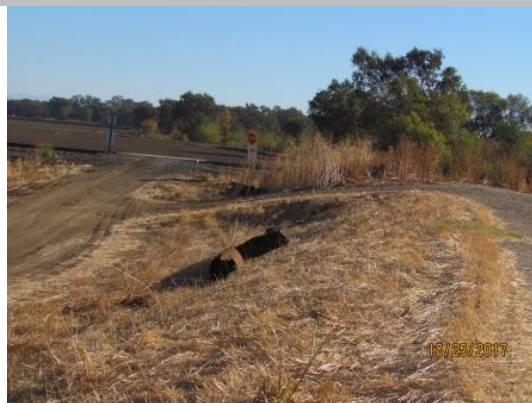
Photo 2 of 2 : FA\_2018\_RD1001\_40\_24\_20180918\_00008.jpg

View of an old piece of pipe lying on landside levee slope looking upstream. Fall 2017.
